**Queensland
Wetlands Program**

Wetland Mapping and Classification Methodology

Attachment 8

Local Hydrology / Disturbance Modifier Examples

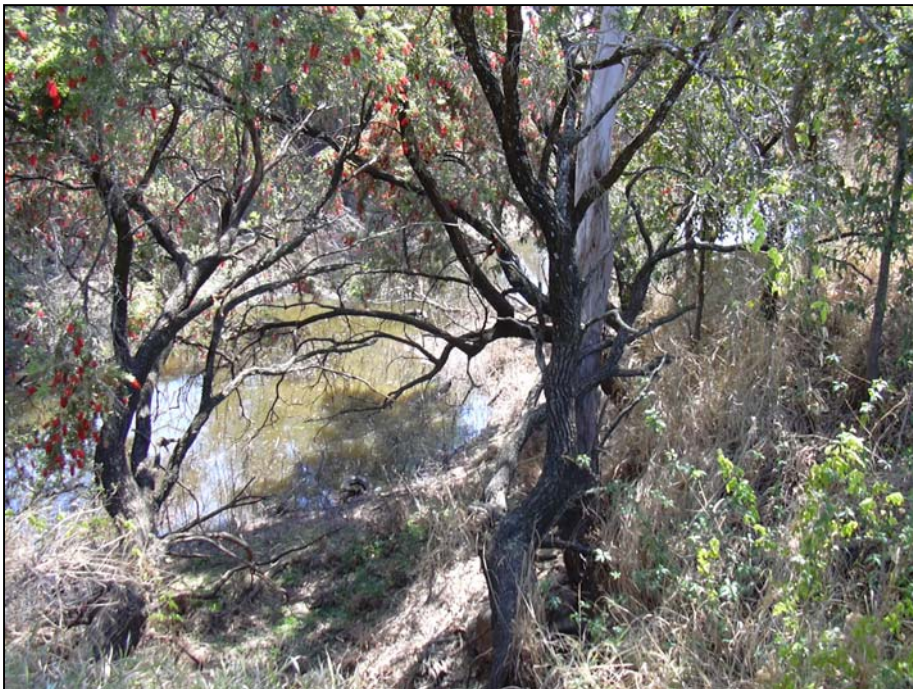
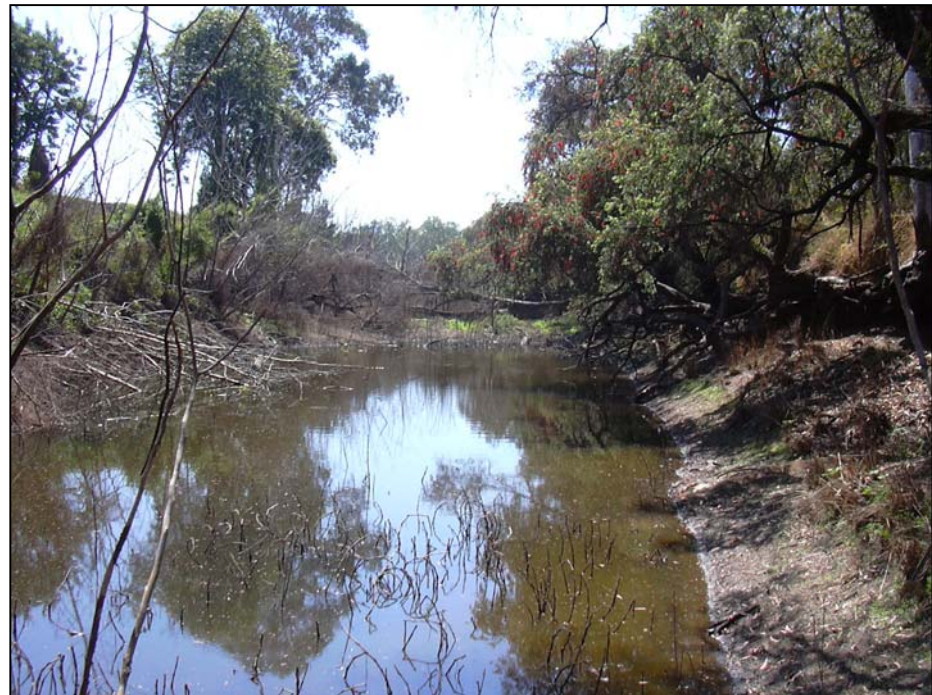
H1 – No obvious local hydrology / disturbance modification

- Hydrological and/or other disturbance includes that which can be determined from satellite imagery or aerial photography such as geomorphological changes; built structures; urban development, i.e. building over wetlands; crops; etc. For example free range grazing etc. would not be included as its impacts would not be clearly visible.
- No evidence of any modifications on Geodata or imagery
- Not on pre-clear map (scale) but looks natural on imagery and is on 1960s (or earlier) photography

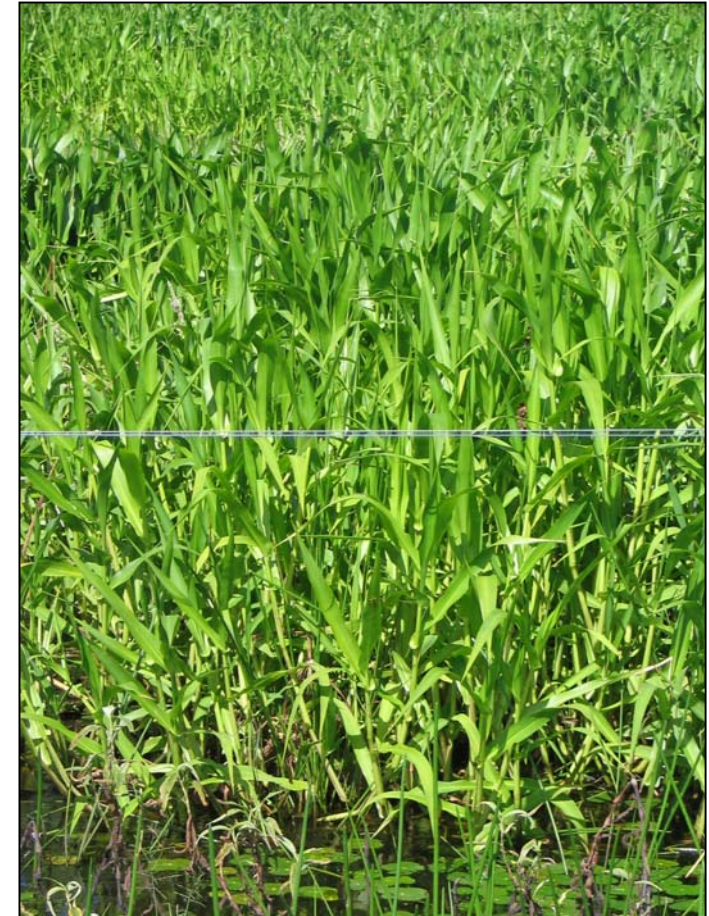
Note:

- H1 may, at this stage, include many examples of floristically altered wetland systems. These altered systems would not be easy (if not impossible in some cases) to determine from the imagery.
- Modifiers are essentially dealing with condition relating to “water” rather than a vegetative “remnant” or other condition and state concept.
- The “ecological” condition of the water body will be captured in the RE allocation stage.

Hymenachne amplexicaulis

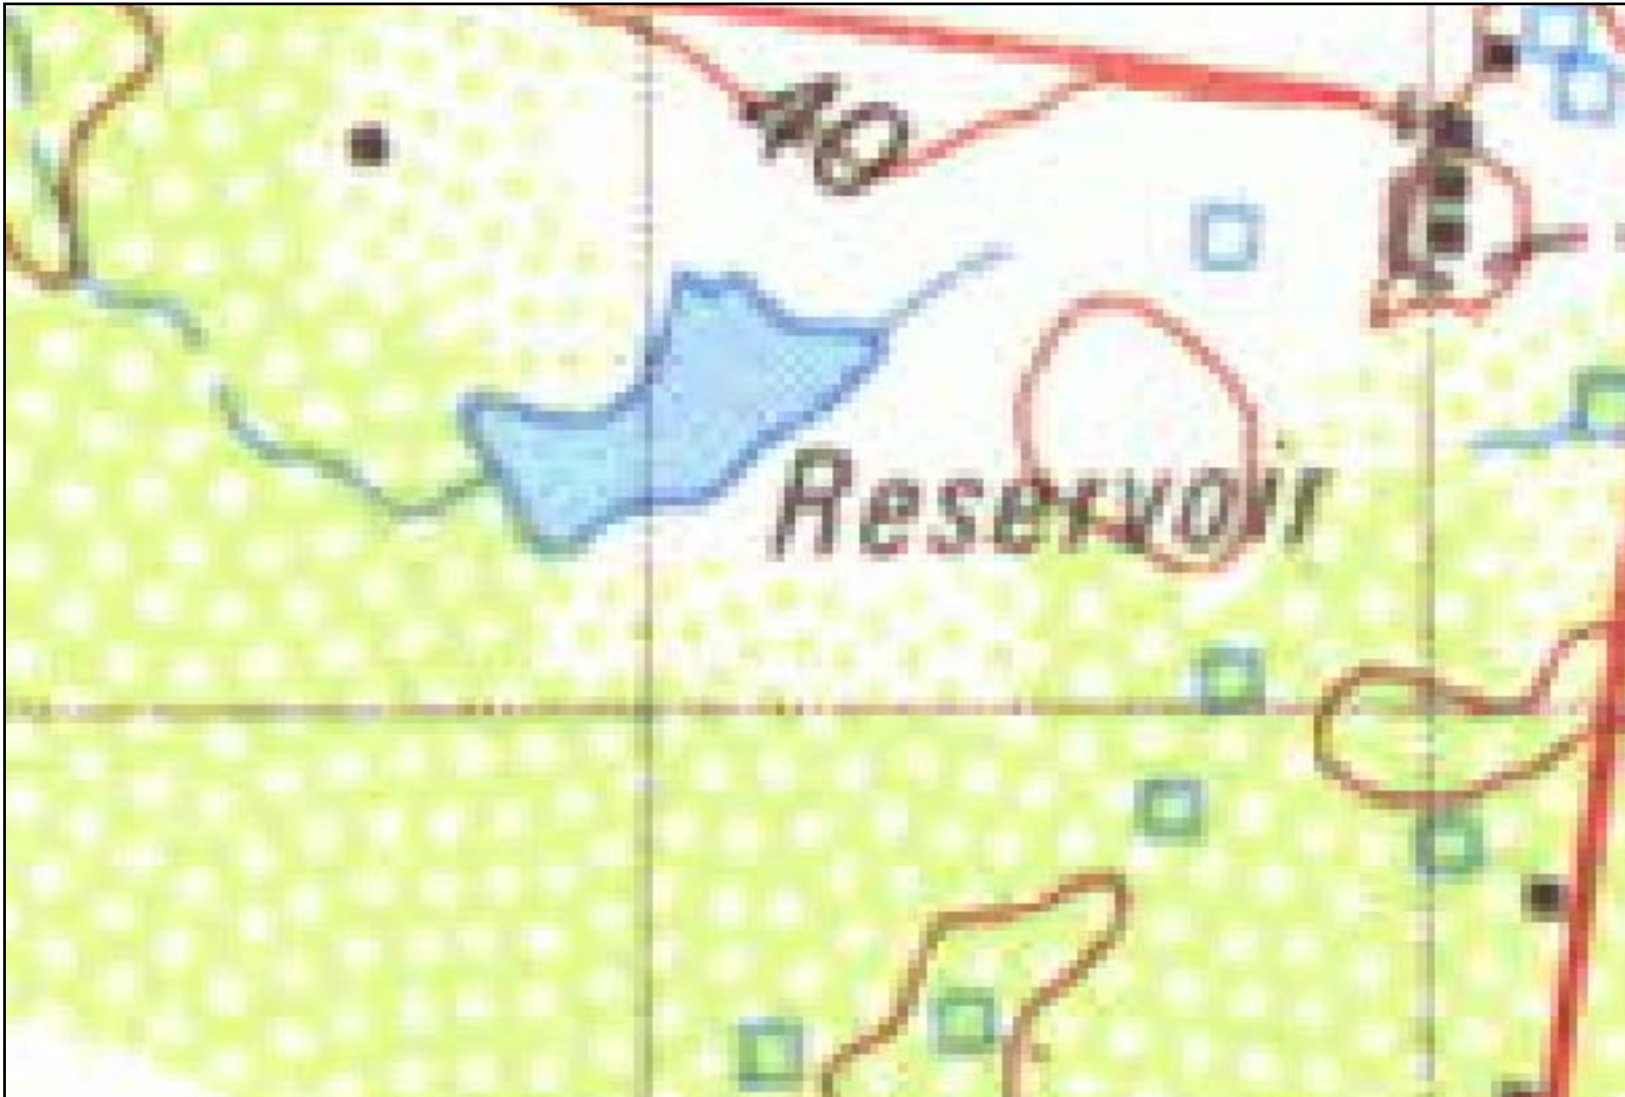
H2M1 – Riverine or ex-riverine (lacustrine) water bodies associated with dams and weirs located in a channel

- Indicated as reservoir across a drainage line on Geodata

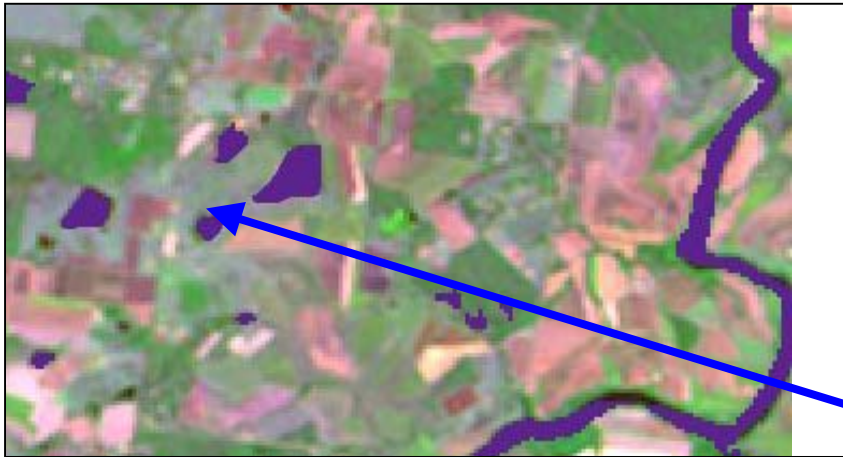
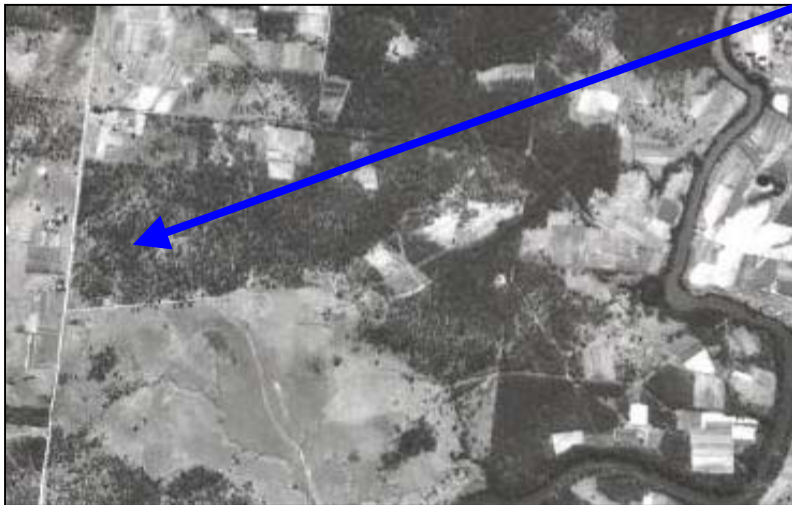
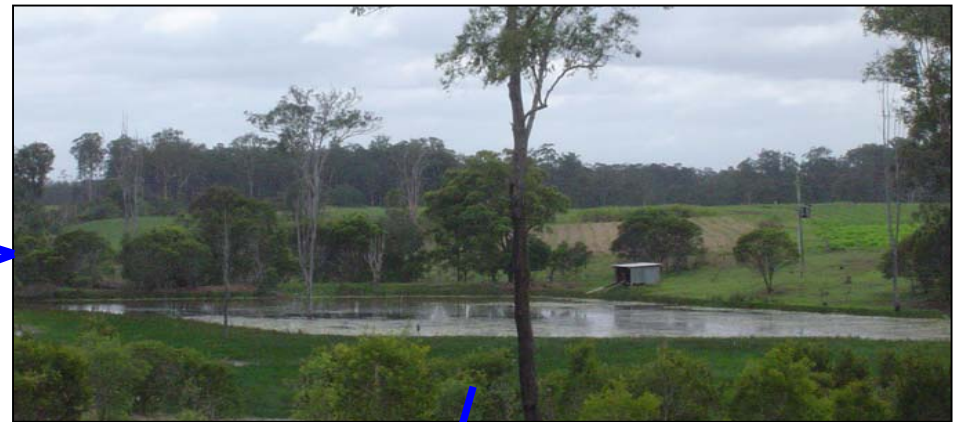
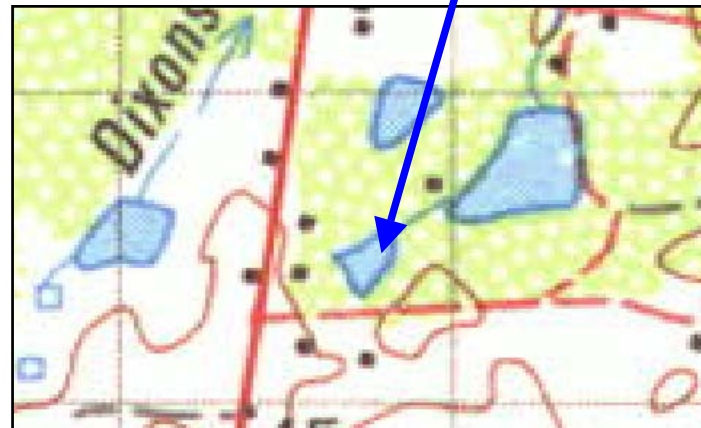
H2M1 continued

- Not on pre-clear/old aerial photos as water body
- On Geodata as drainage line

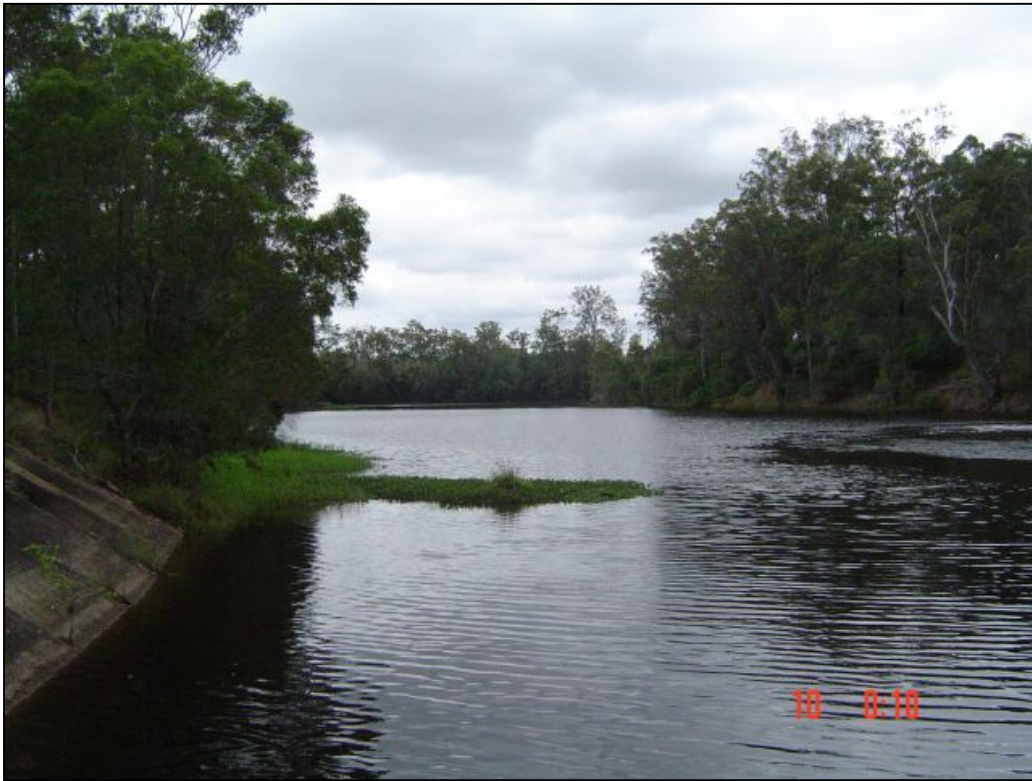
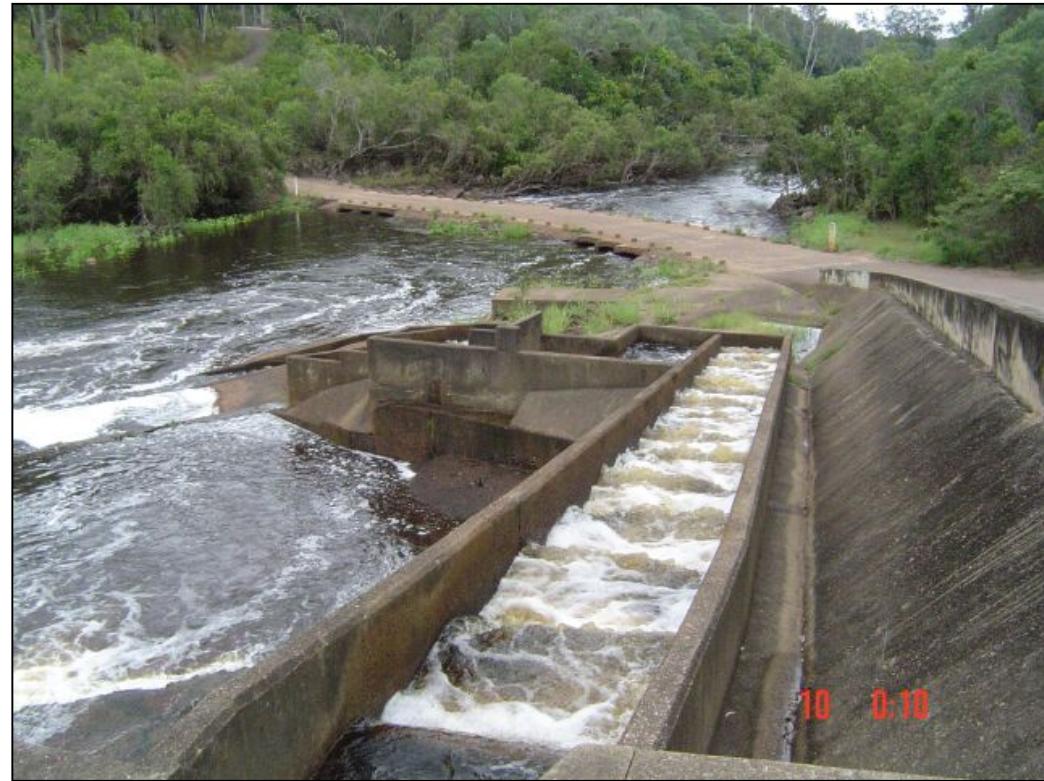
H2M1 – Riverine or ex-Riverine (Lacustrine) water bodies associated with dams and weirs located in a channel

- Does not include reinforced channels in urban areas that are based on natural stream systems (e.g. Norman Creek)

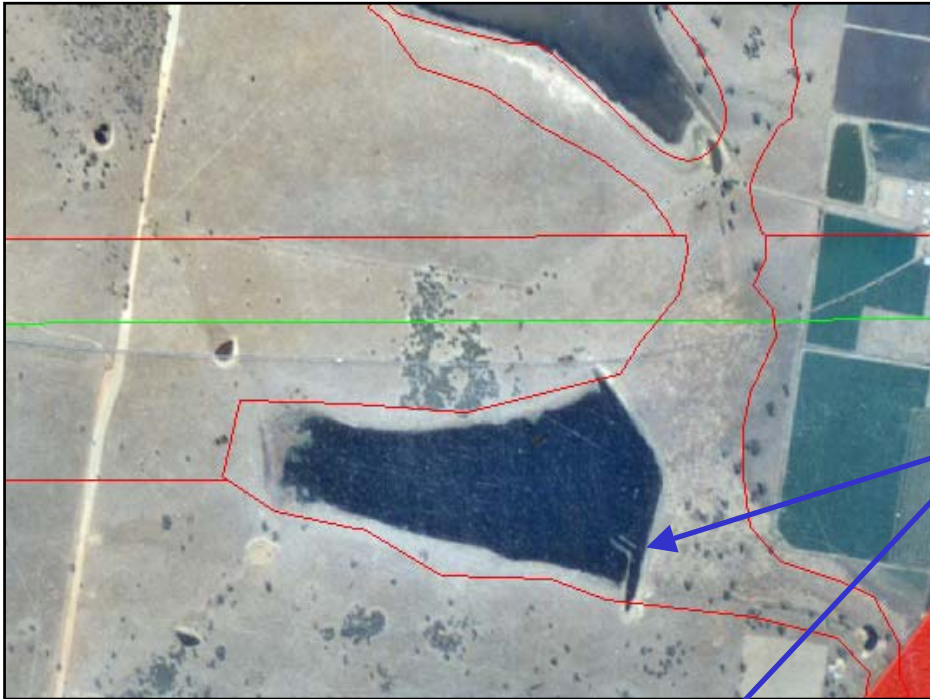
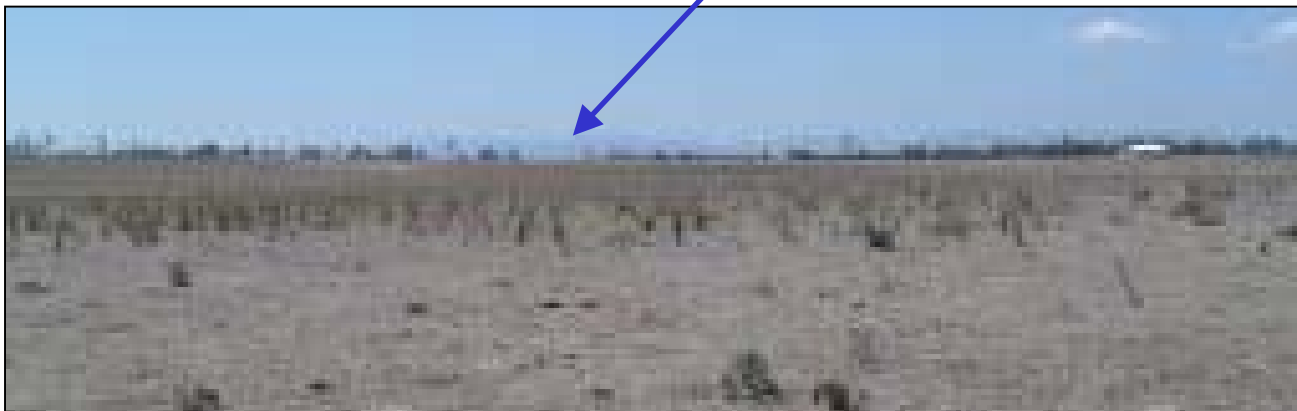
H2M2 – Palustrine/lacustrine water bodies where size and/or hydrology has changed due to levee bank (uncontrolled wall)

- Shown as palustrine wetland on pre-clear (red line) and old aerial photos
- No drainage line on geodata
- Dam wall/levee clearly evident on imagery and in the field

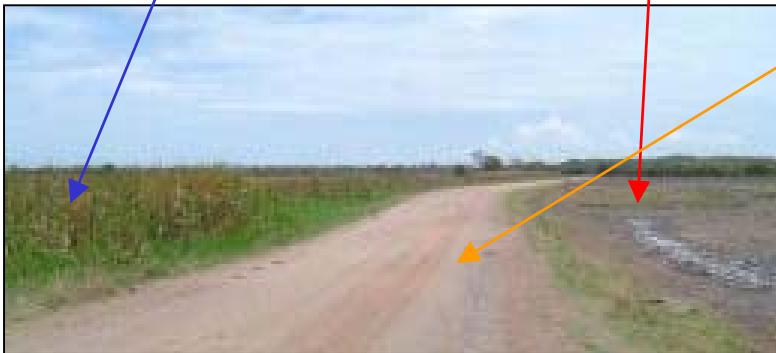
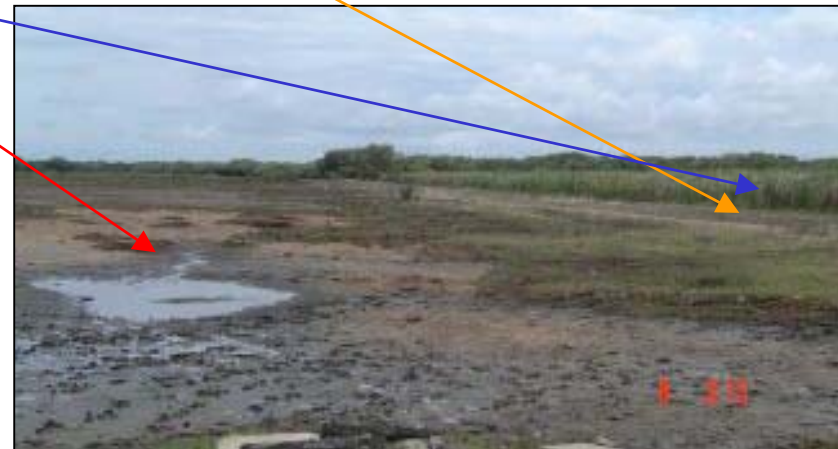
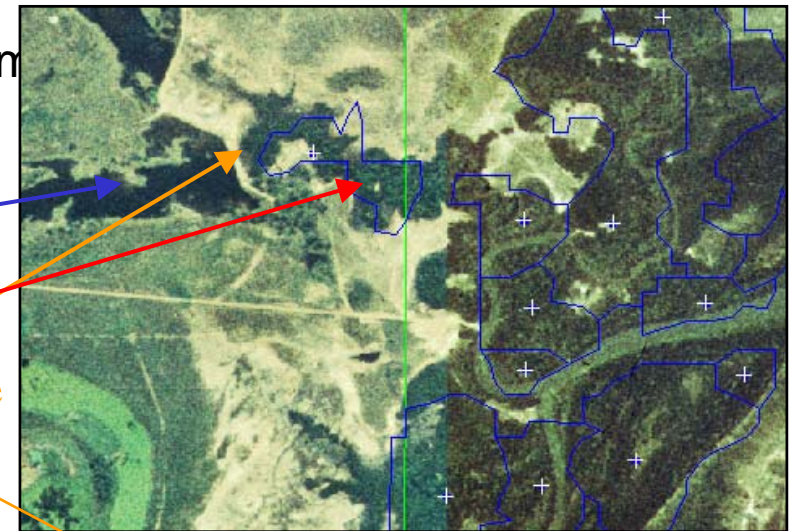
H2M3 – Palustrine/lacustrine water bodies where size and/or hydrology has changed the water body classification from estuarine or marine systems to a fresh water system classification

- Currently freshwater areas that have been converted from estuarine by construction of levees
- Will require detailed inspection of remote imagery to determine modifiers

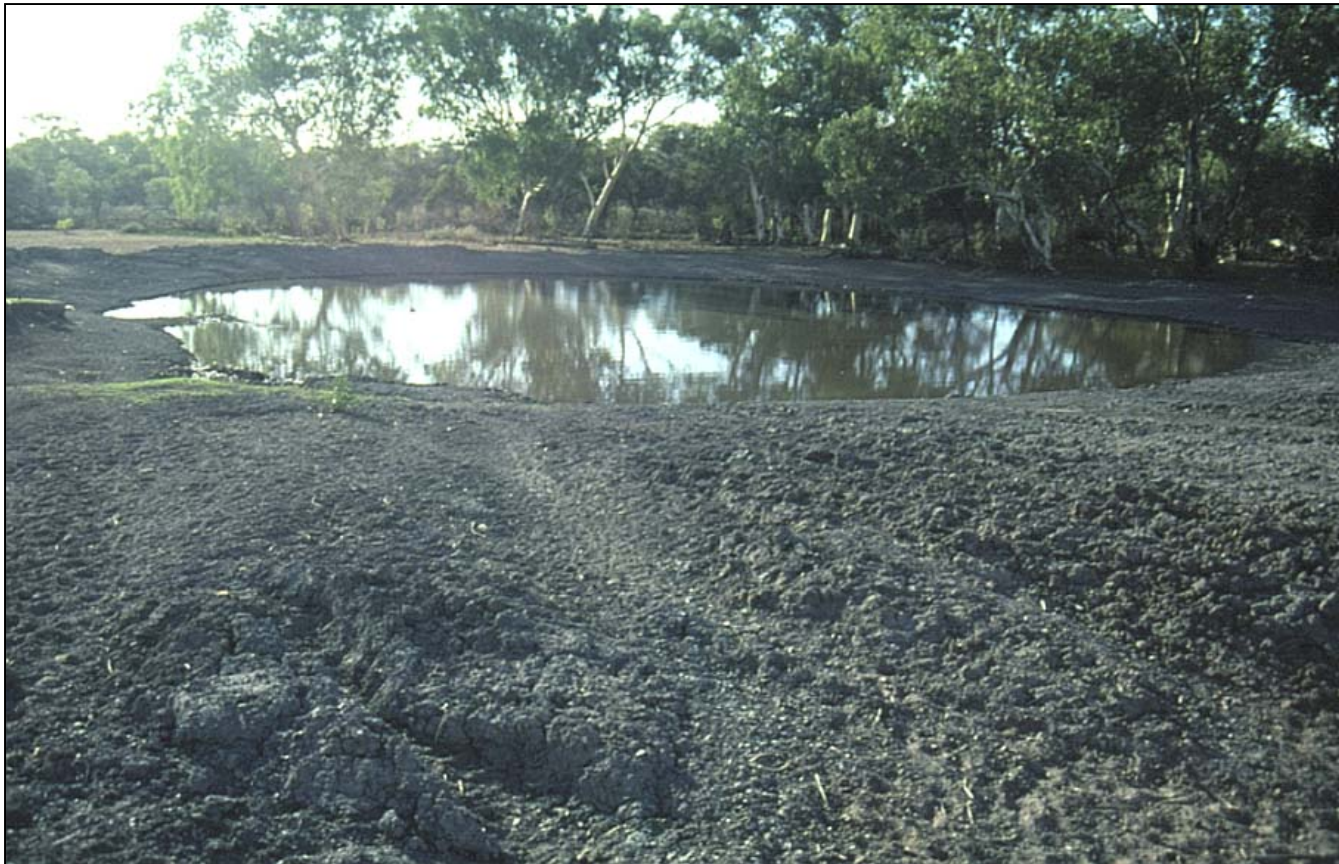
H2M4 – Modified Springs

- Location and modification derived from springs data base which is developed and maintained by Rod Fensham at the Queensland Herbarium
- “Point” feature that will be added to the final wetland data set

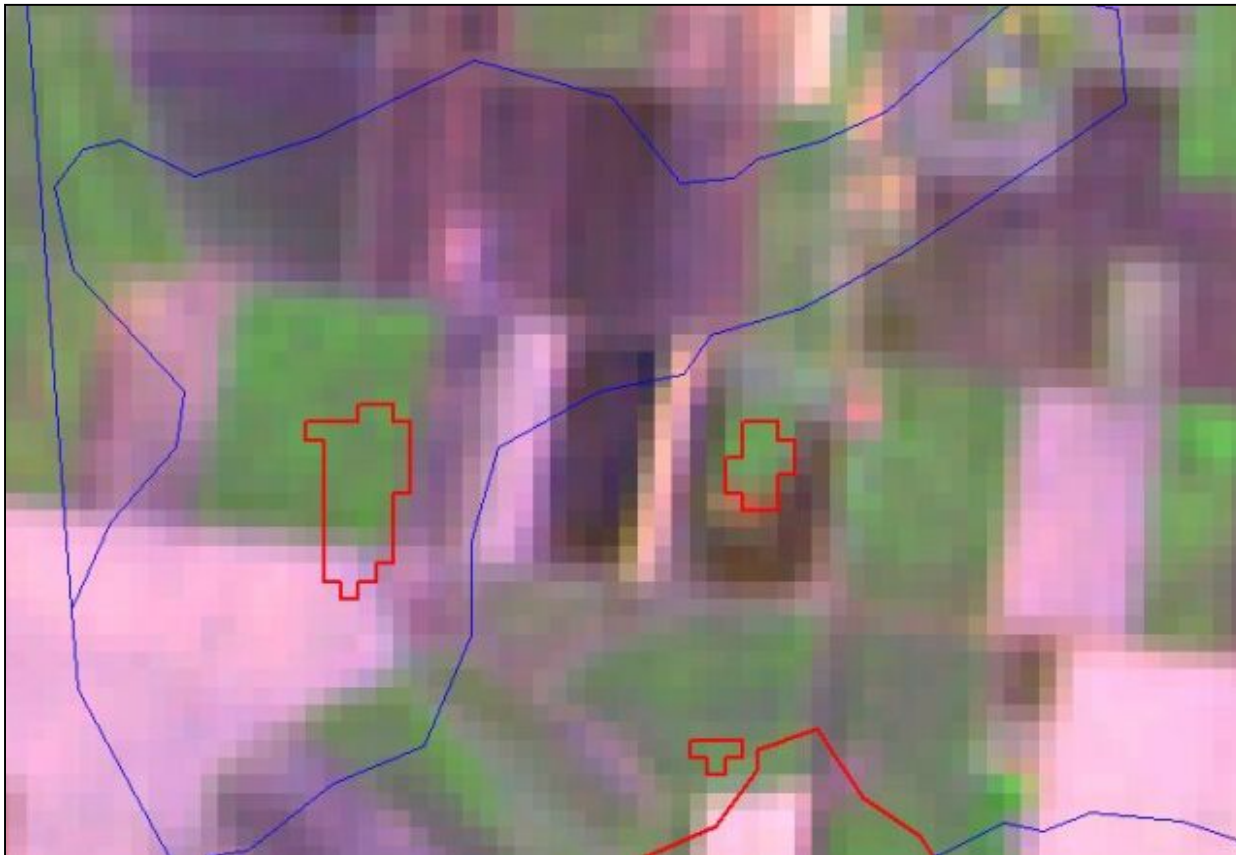
H2M5 – Palustrine/lacustrine water bodies where ecological character has changed due to gross mechanical disturbance, e.g. cropping

- Wetland on pre-clear RE map
- Water body from satellite

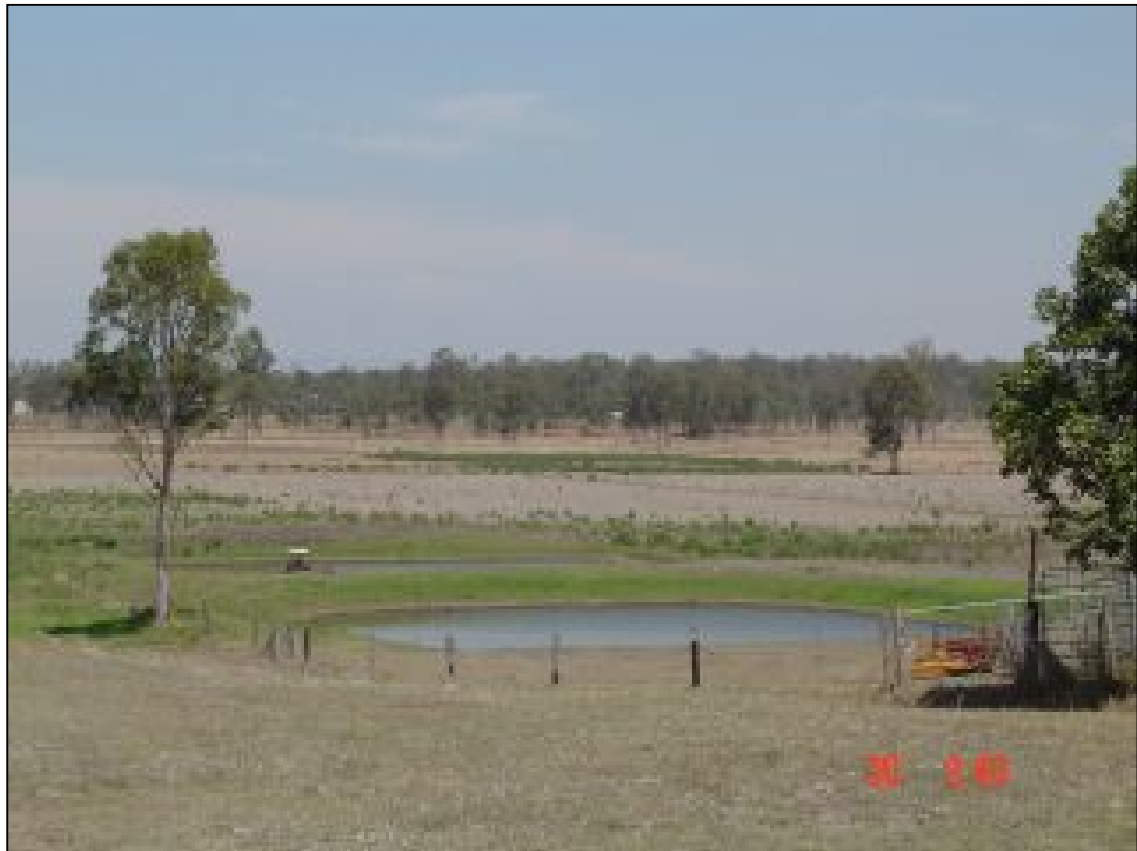
H2M6 – Palustrine/lacustrine water bodies that have been converted, completely or mostly, to a ring tank or other controlled storage

- Stand-alone water body on imagery
- Wetland on pre-clear or old aerial photos
- Usually ring tanks etc.

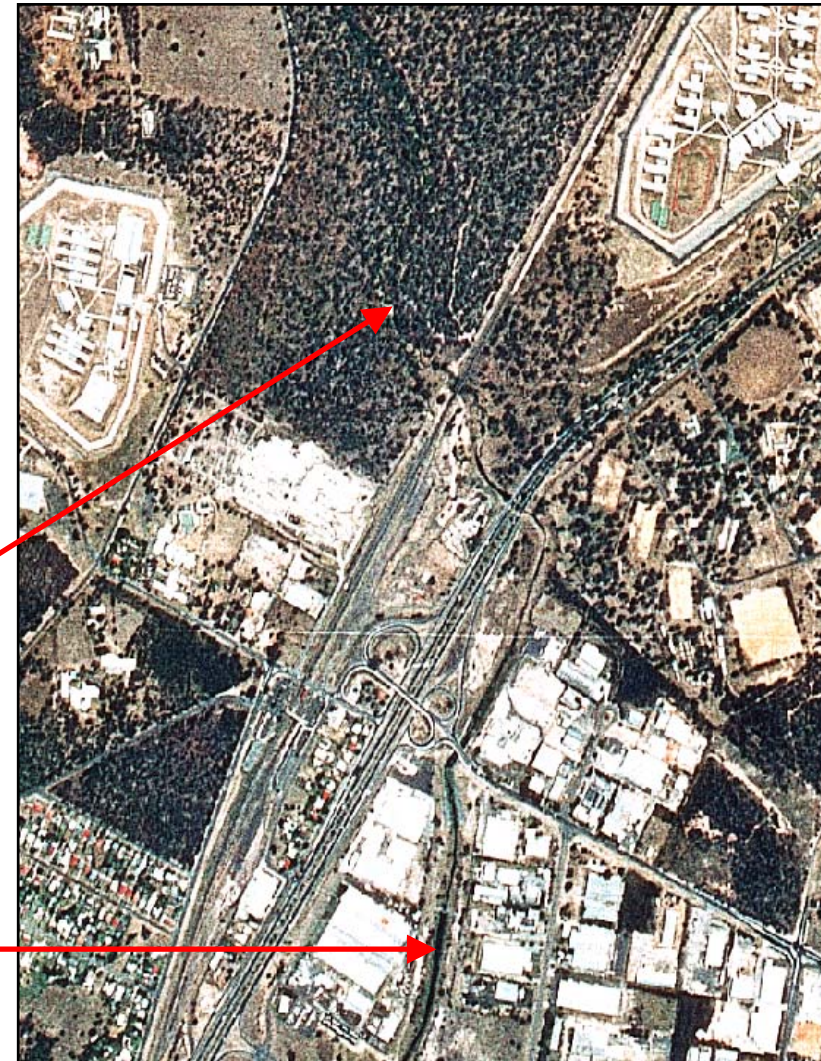
H2M7 – Riverine water bodies that have been converted mostly to canals or irrigation channels

- Pre-clear riverine systems
- Converted to reinforced channels for flood mitigation etc.
- Usually urban areas – perhaps some irrigation scenarios?
- Example – Sandy Creek at Wacol
- Must fall on natural drainage system (compare H3C2)

Natural stream channel
wb_nat_mod = H2M7
wb_class = R

Reinforced stream channel
wb_nat_mod = H2M7
wb_class = R

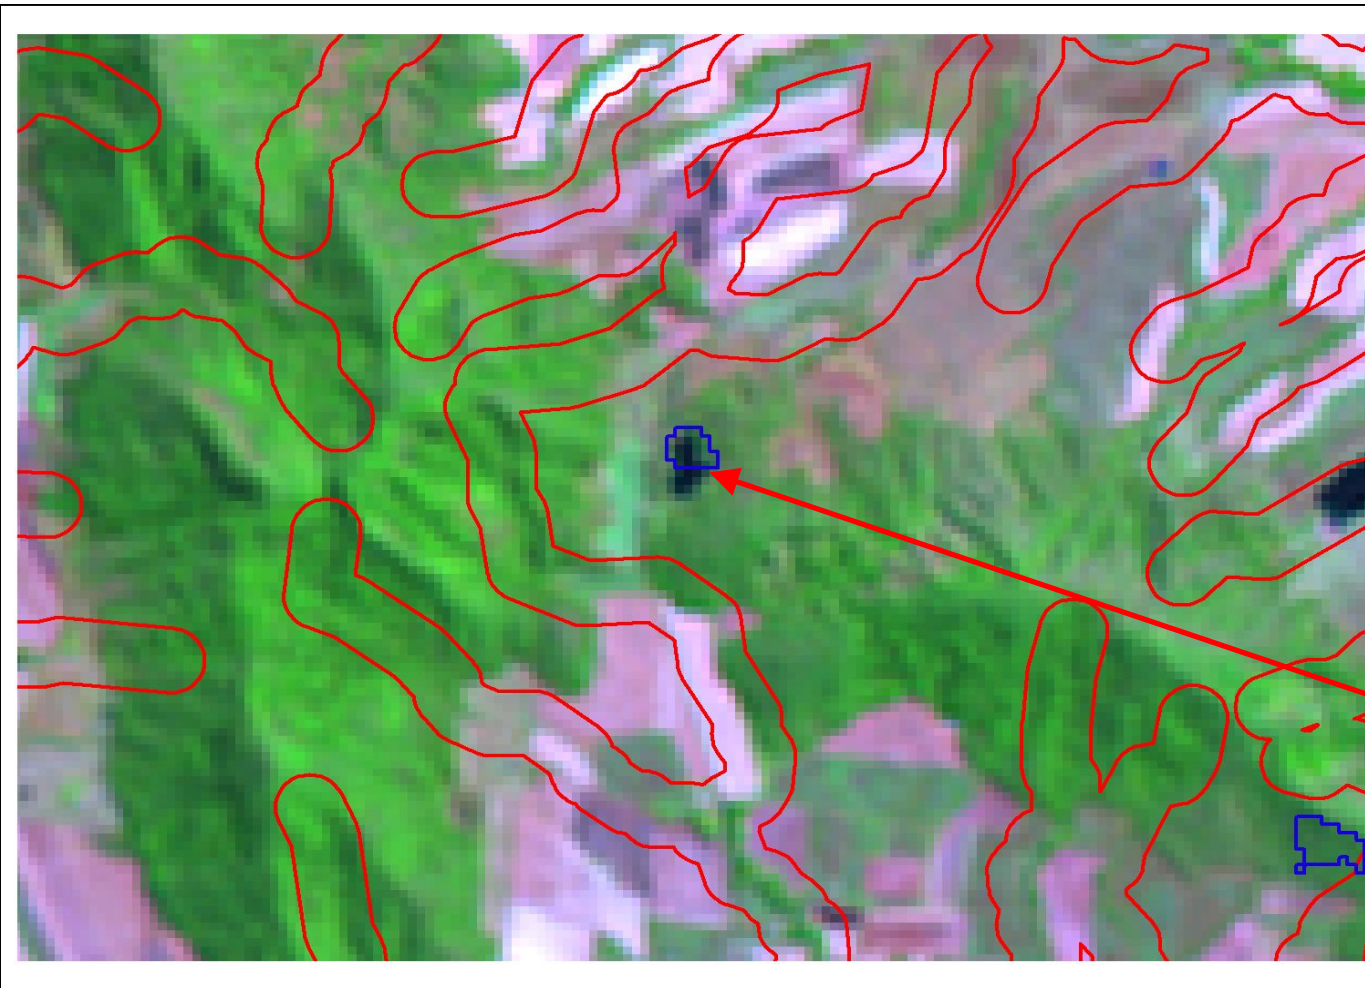
H3C1 – Artificial stand-alone water storages not within a natural water body or channel

- Artificial entities completely divorced from original drainage network
- Walled structures

'Offline' water body outside riverine buffer:
wb_nat_mod = H3C1
wb_sal_mod = S1
wb_class = L

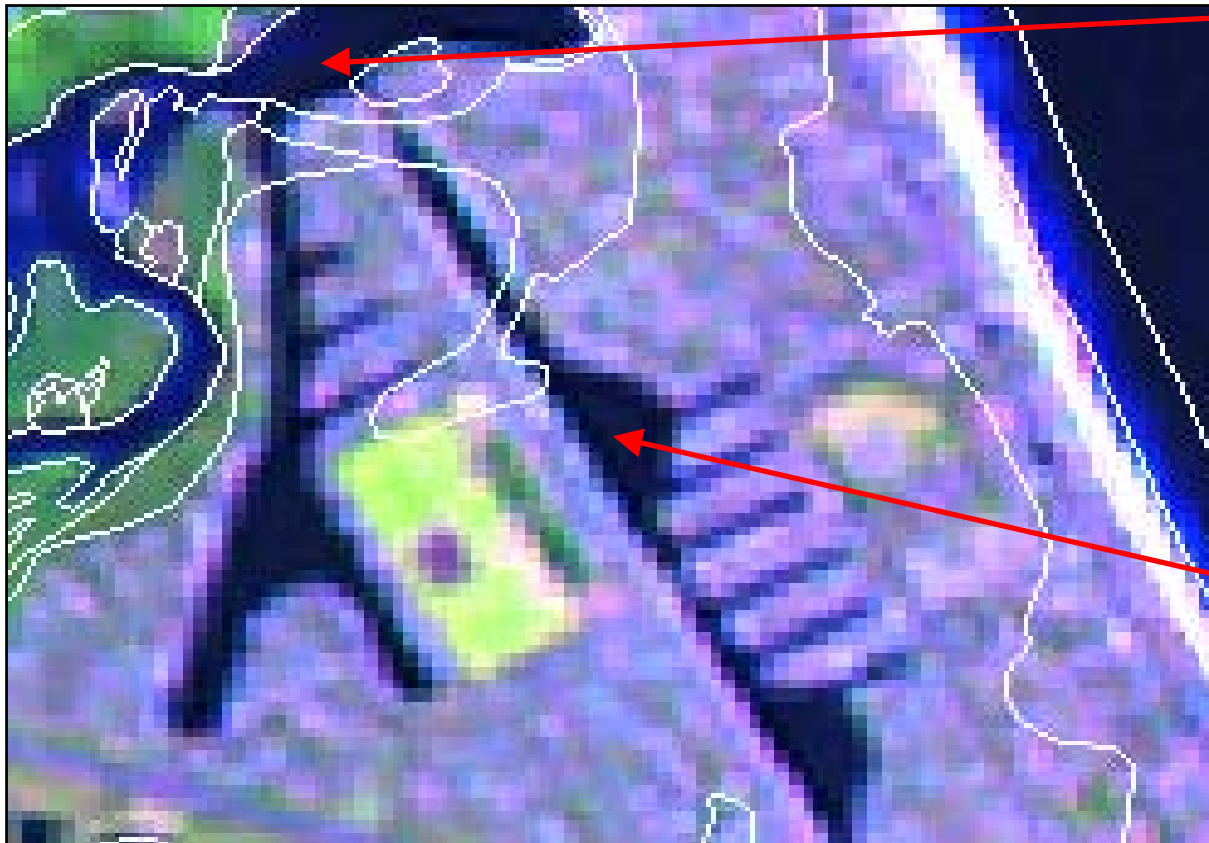
H3C2 – Artificial channel drain/canal – bore drains, swales, bores and irrigation channels overflows/ponding

- Artificial entities completely divorced from original drainage network
- Will be separated from adjacent drainage system on basis of original hydrology
- Differentiated from H2M7 reinforced channels in natural streams

Original stream channel H1 or H2. If remnant classified as RE water feature:
wb_nat_mod = H1
wb_sal_mod = N.A.
wb_class = E

Not present as water feature in pre-clearing or historical aerial photography:
wb_nat_mod = H3C2
wb_sal_mod = N.A.
wb_class = E (recalculated)

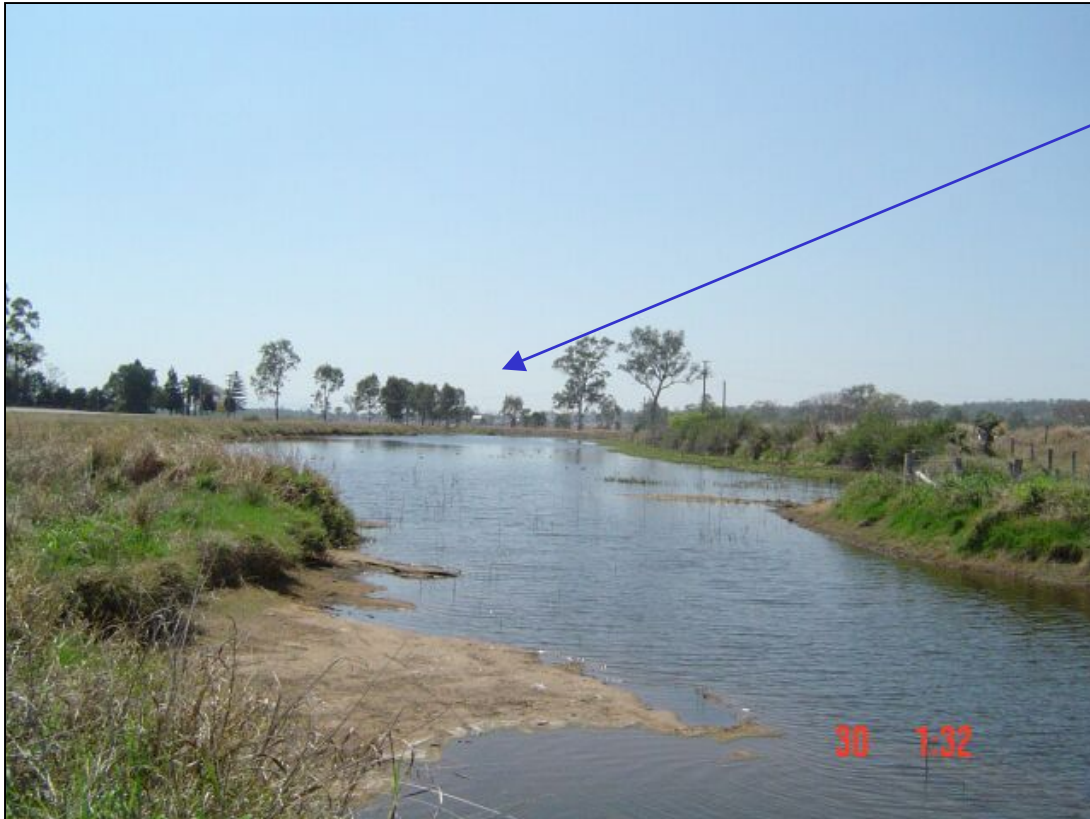
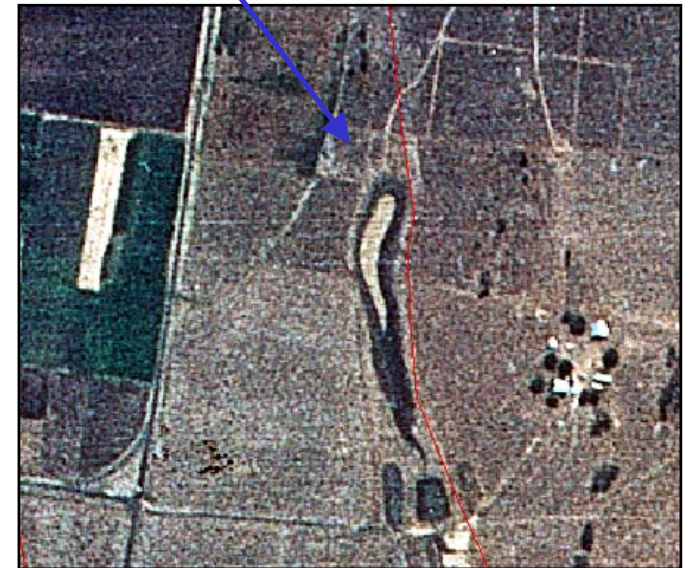
Misclassification Issues

- H1 Water body with no obvious local hydrological and/or other disturbance, which may be distinguished from the mapping – riverine area with no obvious modifications
- But ground truthing/DNRM water storage mapping revealed construction of a dam wall; drainage line that has been modified should therefore be H2M6

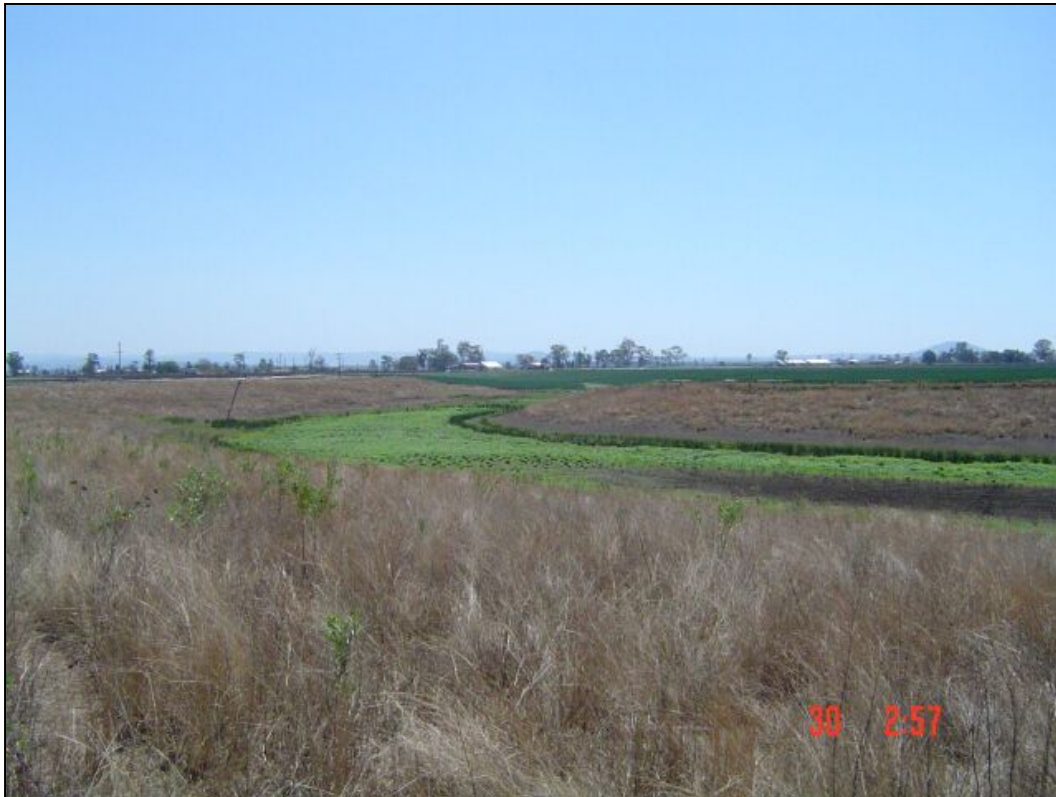
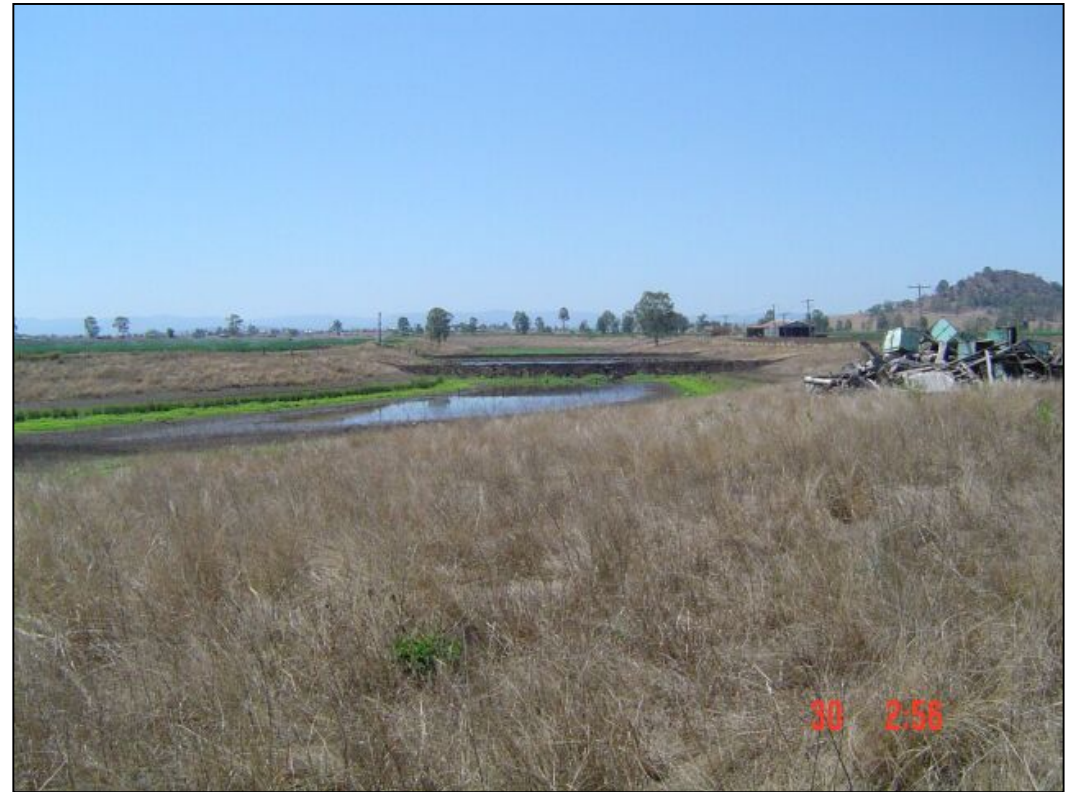
Misclassification as H1

- no obvious walls
- but ground truthing DNRM water storage mapping found that the water body is used as a water storage and should be H2M6
